**NIOSH**  
Fire Fighter Fatality Investigation  
and Prevention Program

## Live-Fire Exercise in Mobile Flashover Training Simulator Injures Five Career Fire Fighters - Maine

## Fatality Assessment and Control Evaluation Investigative Report #F2003-41

### ***Live-Fire Exercise in Mobile Flashover Training Simulator Injures Five Career Fire Fighters***

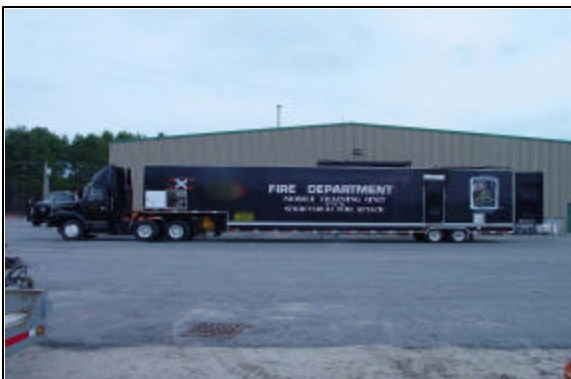
*Mobile Training Trailer*

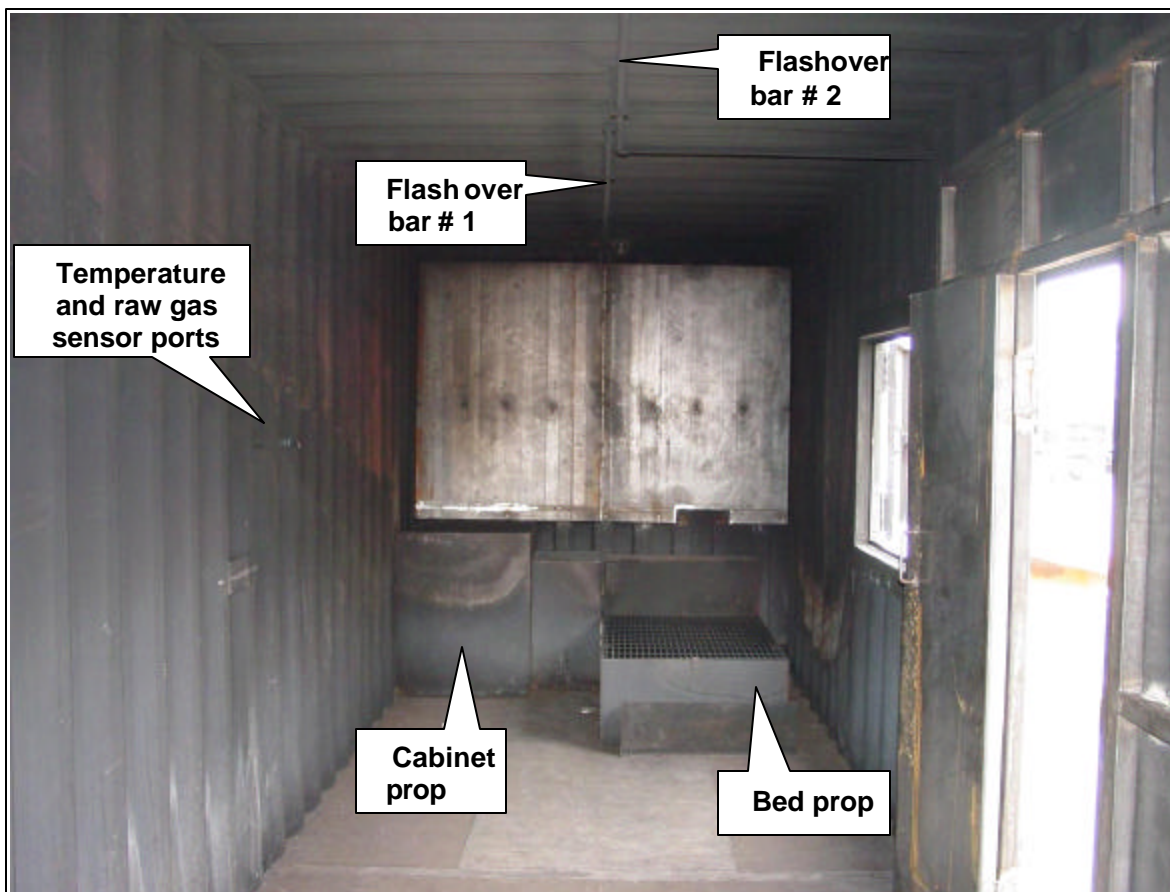
*Photo 1. Inside view of front of burn chamber*

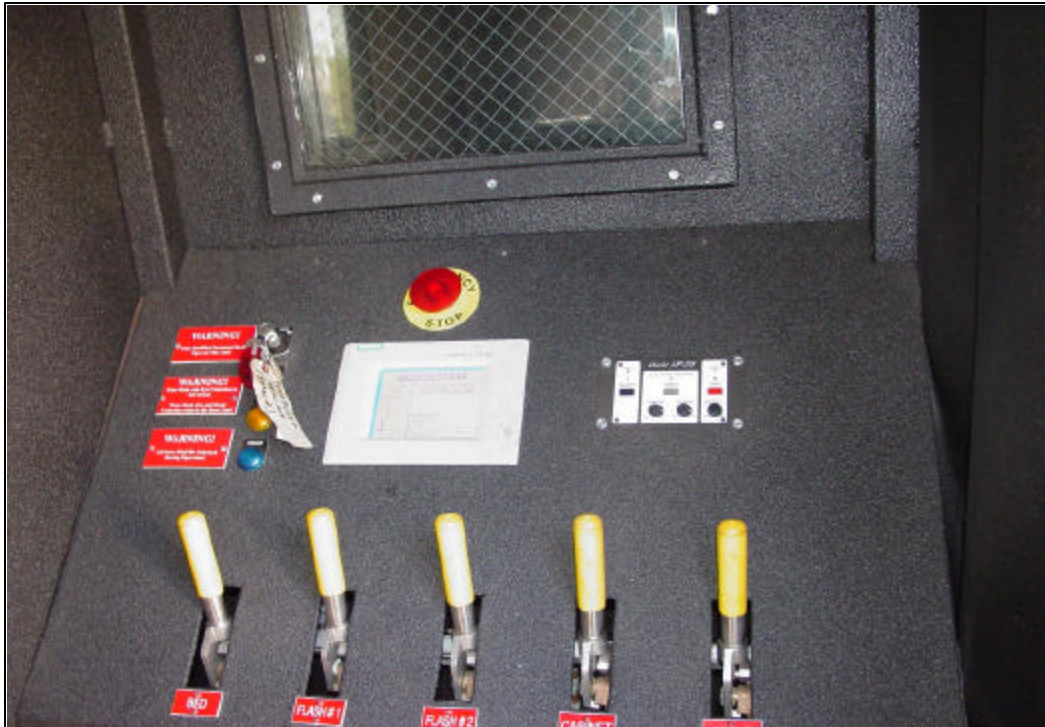
Discussion: The trailer involved in this incident is designed with hand-operated gas control valves that must be manually opened and closed to control the flow of propane to the various props within the burn chamber. This design allows for the possibility of opening and closing valves improperly, with the potential to lead to unsafe conditions if the manufacturer's operating procedures are not properly followed. The use of electronic programmable logic controllers would reduce or eliminate the possibility of improper operation. Integrated carbon monoxide and other sensor systems could automatically shut down the system in a fail-safe mode whenever unsafe levels of explosive gases are encountered within the simulator. Additional strategically located fuel sensors

*Photo 2. Operator control panel. Individual gas control valves are shown at the bottom*

***Recommendation # 6: Training simulator manufacturers should consider using programmable logic controllers (PLC) and computerized electronic data monitoring systems to avoid the possibility of improper system operation.***

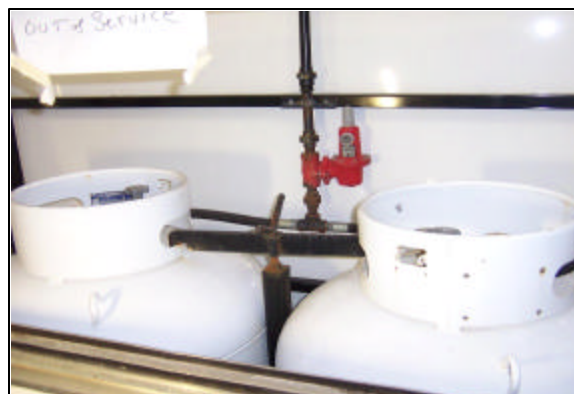
The three burn props and the two flashover bars are fueled by compressed liquid propane gas (LPG). Two 420 pound steel tanks are mounted vertically in the front of the equipment room to provide fuel to the props and flashover bars. (Photo 3)

*Photo 3. LPG cylinders in equipment room at front of trailer.*

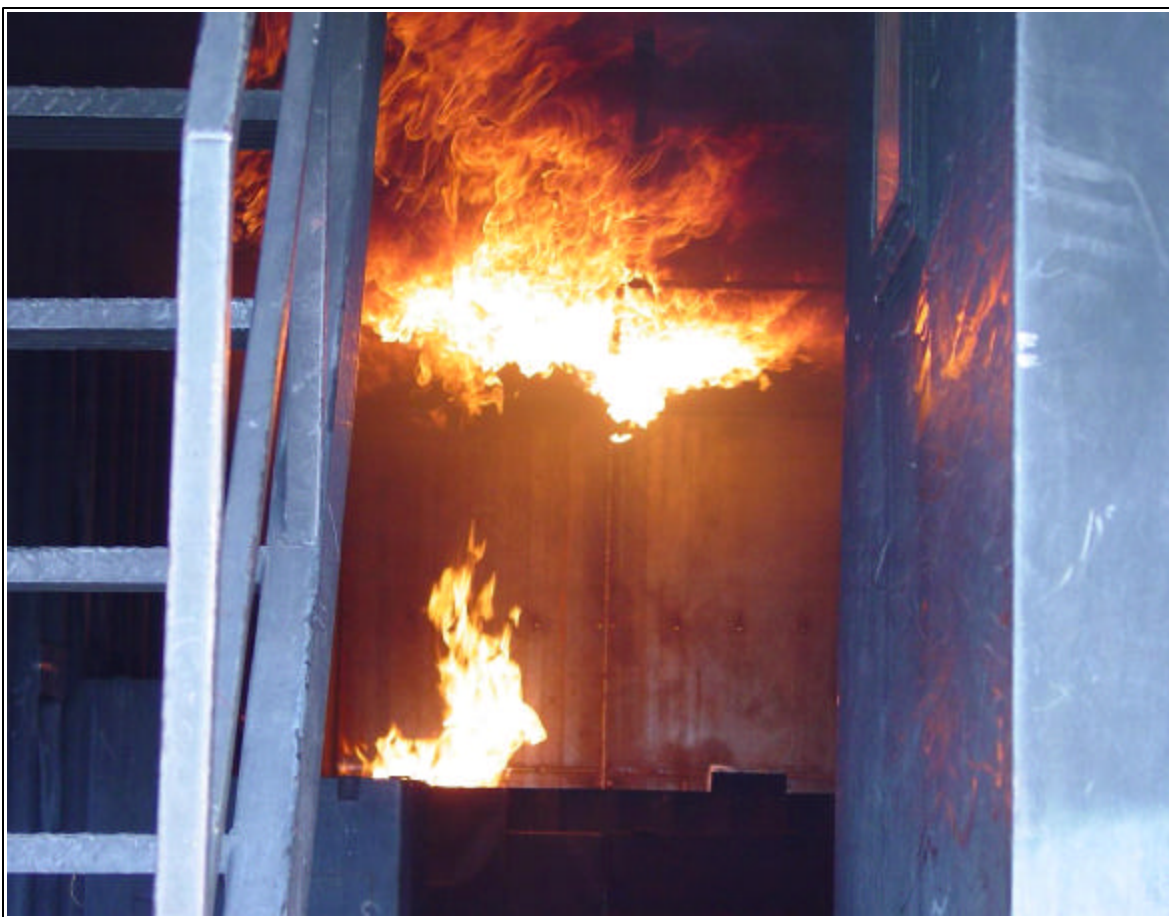
*Photo 4. View thru rear doors showing cabinet prop at lower left and flashover bar at ceiling ignited. Dividing partition walls have been swung out of the way.*

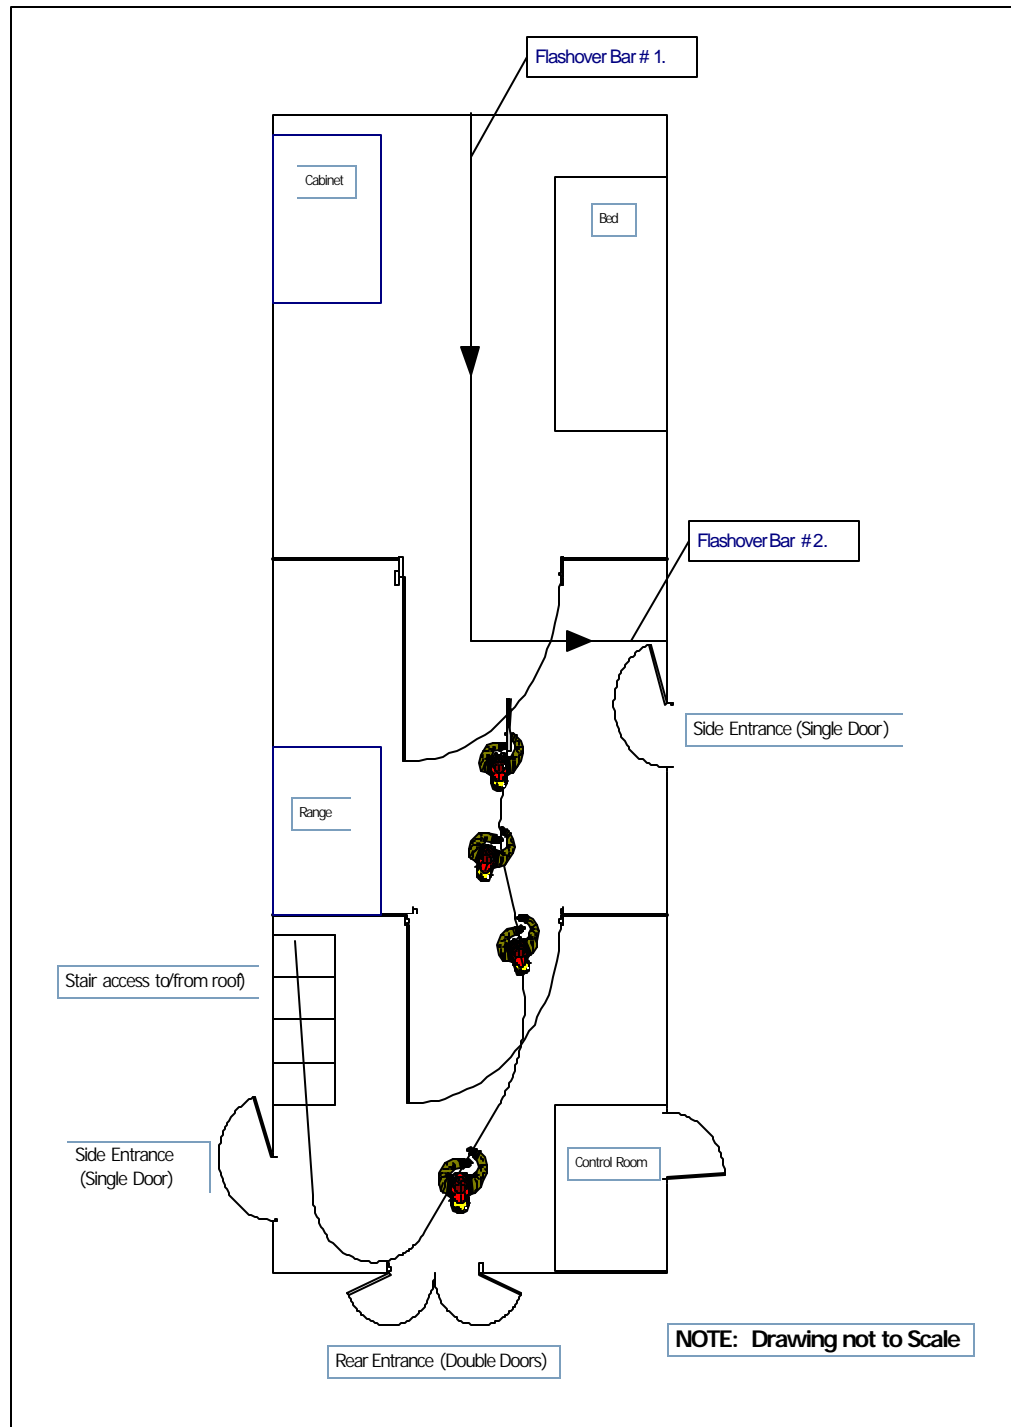
mounted flashover bars (1-inch perforated pipes) extend from the front of the burn chamber past the first partition wall. The burn chamber has 3 entrance doors, two windows, an exhaust ventilation fan, a roof hatch and an operator control room isolated from the rest of the burn chamber (Figure 1).

second fire fighter (backup man on hoseline) advanced through the doorway. They had not yet begun to apply water to the fire. The Ladder 4 captain was third on the hoseline and was just passing through the doorway when an explosion occurred somewhere in front of the crew, knocking them backward. Just prior to the explosion, three of the four crew members reported seeing a white fog or cloud in the air inside the trailer. None of the crew members received any damage to their personal protective equipment or clothing. None of the crew members saw a "fireball" or experienced an increase in heat at the time of the explosion. They all reported hearing the sound of an explosion and feeling the pressure wave as it knocked them backward. The force of the explosion blew open the trailer's outer doors and windows. The Ladder 4 crew members were shaken-up and disoriented, but were able to exit the trailer under their own power. A fifth fire fighter, stationed outside the trailer to monitor the left side exit door, was slightly injured when the force of the explosion caused the door to swing open and strike him on the shoulder. A fire department ambulance and EMS crew were dispatched to the training site and the injured fire fighters were treated on scene. None were transported following the incident.

*Figure 1. Training trailer layout showing location of Ladder 4 crew at time of explosion*
